# **Cargo Compartment Fire Protection in Large Commercial Transport Aircraft**

July 1998

DOT/FAA/AR-TN98/32

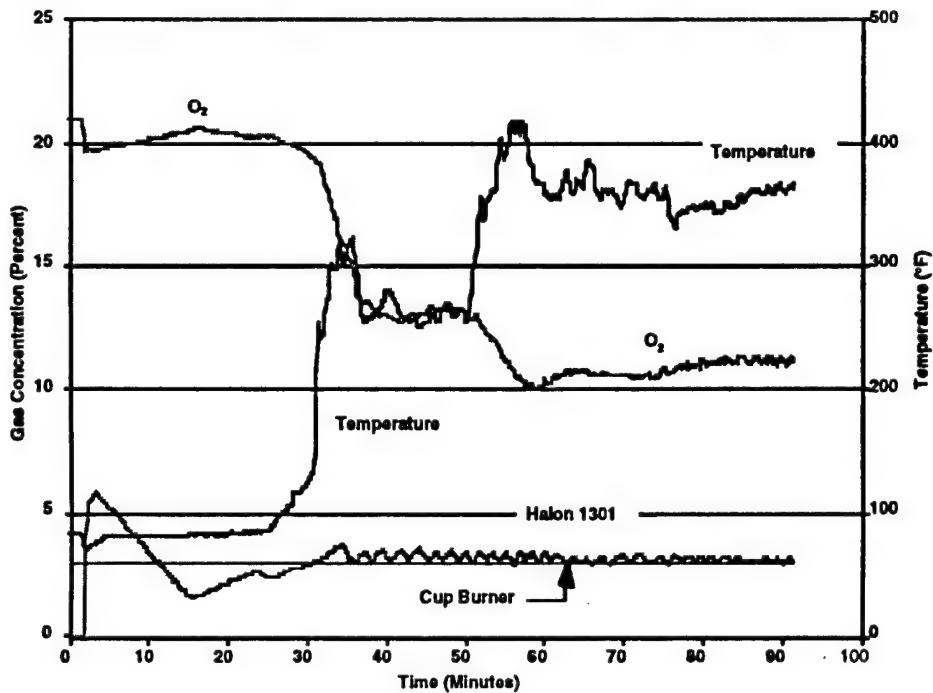
FIGURE 1. GAS AND TEMPERATURE PROFILES IN CARGO COMPARTMENT DURING BULK-LOADED FIRE SUPPRESSION TEST WITH HALON 1301

The results of these 90-minute tests were generally similar to previous shorter duration tests conducted with these agents. [8] The cargo compartment ceiling temperatures ranged from 300 to 450°F while the fires were suppressed and the oxygen concentrations were reduced to 10% to 15%. The depletion of oxygen was caused both by smoldering fires and the displacement of air by suppression agents. Figures 1 and 2 show the ceiling temperatures, oxygen concentrations, and agent concentrations measured in the cargo compartment for the tests with Halon 1301 and HFC-125, respectively. One anomaly was observed during the test with HFC-125. Shortly after the concentration from the initial discharge had decayed down to the cup burner value of 8.8% and the metering system had started, there was an ignition of combustible gases in the smoke layer above the cardboard boxes. The flame front progressed along the entire length of the compartment at the ceiling level. This caused a sharp rise in ceiling temperature and a drop in oxygen concentration. The fire was suppressed for the duration of the test after this event. A similar event had previously been observed in a test using HFC-125 with a containerized fire load. This type of behavior had not been observed with Halon 1301 or other gaseous candidate replacement agents. Further testing is planned in an attempt to understand this anomaly.

Of particular interest for these longer duration tests was the generation and accumulation of agent decomposition products in both the cargo compartment and in the normally occupied passenger cabin area above it. Figure 3 shows the hydrogen fluoride (HF) concentrations in the cargo compartment for the two tests. The values in the graph are the average concentrations of HF over each 10-minute interval. The higher concentrations of HF between 20 and 40 minutes with HFC-125 are due mainly to the open flame that was present when the combustible gases along the ceiling ignited. This open flame produced significantly more decomposition products than the smoldering suppressed fire. Previous testing showed higher concentrations of HF even where there was no ignition of combustible gases when HFC-125 was used as the suppression agent rather than Halon 1301. This result is expected because not only does HFC-125 contain more fluorine per molecule than Halon 1301, but higher concentrations of HFC-125 are also

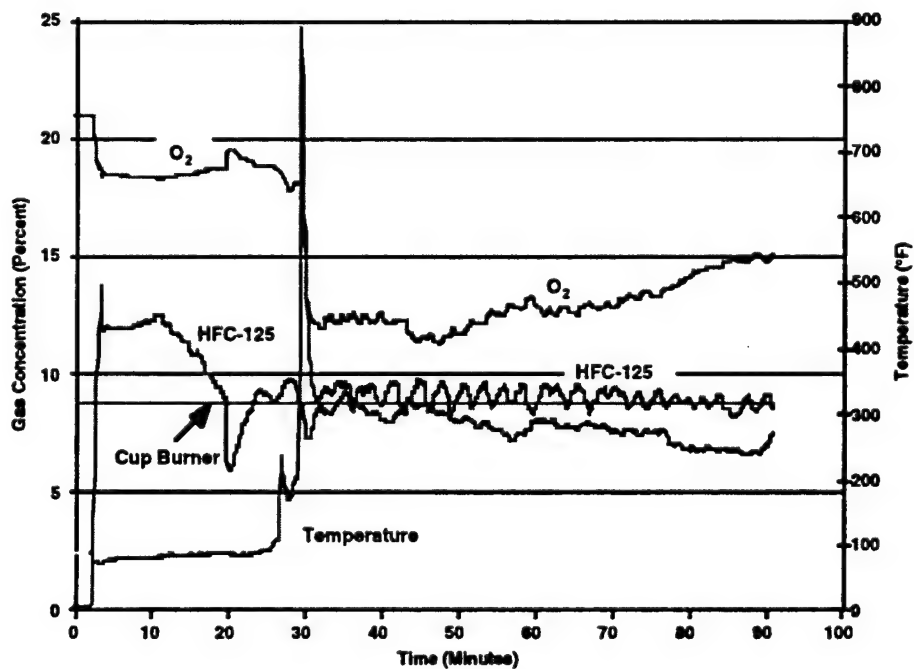
FIGURE 2. GAS AND TEMPERATURE PROFILES IN CARGO COMPARTMENT DURING BULK-LOADED FIRE SUPPRESSION TEST WITH HFC-125

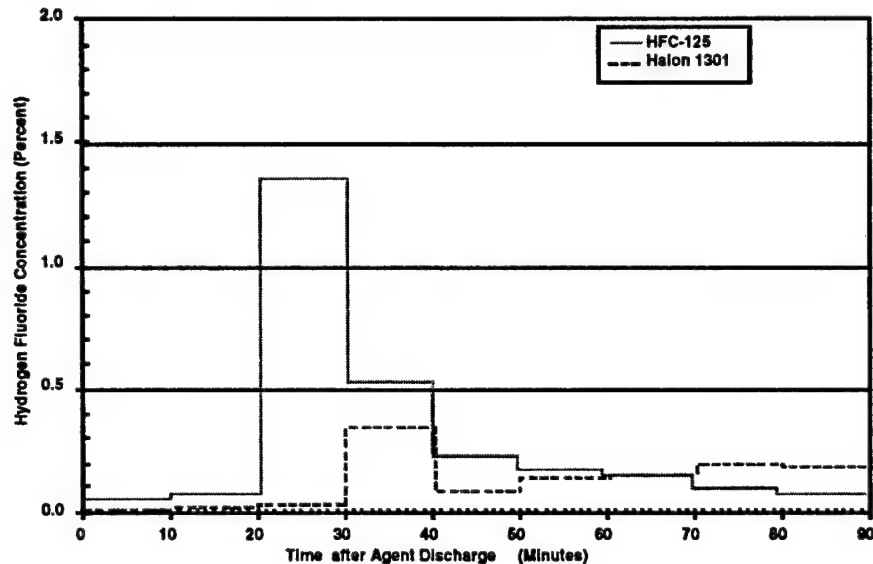
FIGURE 3. HYDROGEN FLUORIDE PROFILES IN CARGO COMPARTMENT DURING BULK-LOADED FIRE SUPPRESSION TESTS WITH HALON 1301 AND HFC-125

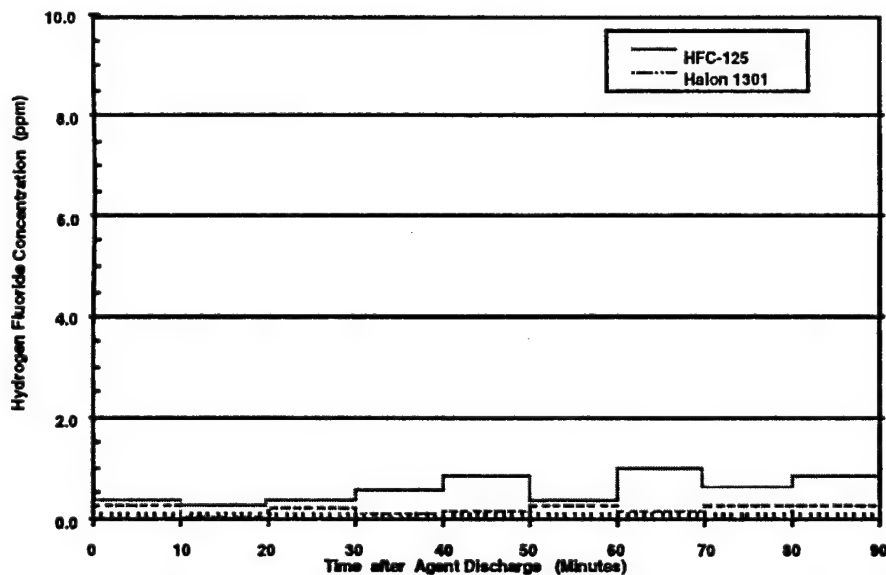
FIGURE 4. HYDROGEN FLUORIDE PROFILES IN PASSENGER CABIN DURING BULK-LOADED FIRE SUPPRESSION TESTS WITH HALON 1301 AND HFC-125

required compared to Halon 1301. Figure 4 shows the HF concentrations in the passenger cabin above the cargo compartment. HF concentrations are again higher in the test with HFC-125 for the same reasons as stated above. However, the data show that there is not a significant accumulation of HF in the cabin area. The fuselage ventilation system exhausts the decomposition products out of the cabin at a rate similar to the inflow rate of these products. The measured levels for both tests were well below the maximum Occupational Safety and Health Administration (OSHA) 15-minute exposure limit of 6 parts per million (ppm) and the Immediately Dangerous to Life and Health (IDLH) limit of 30 ppm.

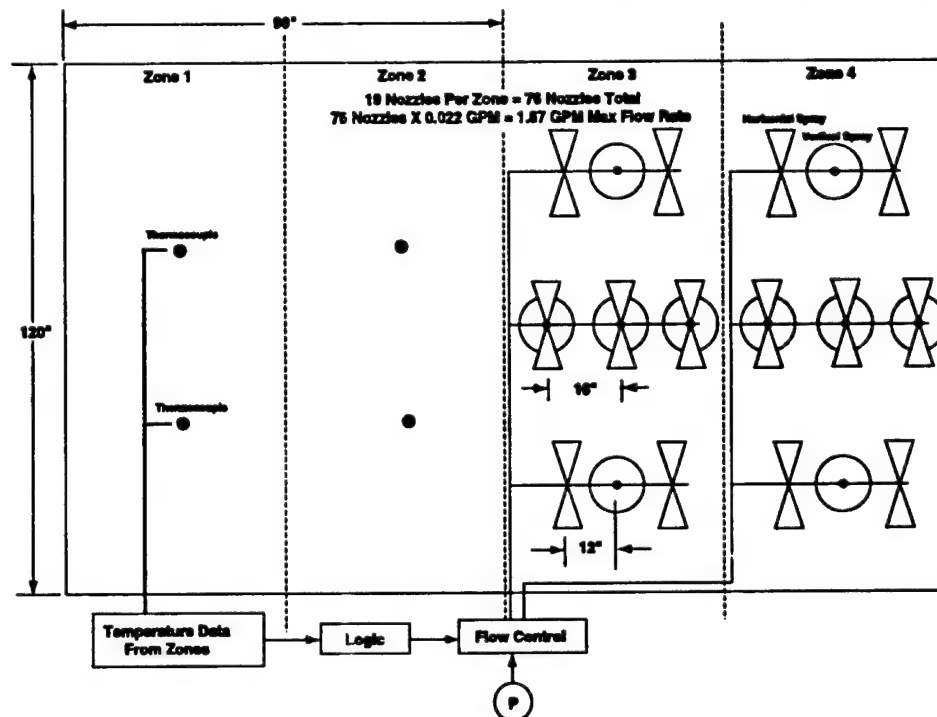
FIGURE 5. WATER MIST SYSTEM SCHEMATIC

The water mist system was supplied by Environmental Engineering Concepts (EEC). These systems are commercially available under the trade names Microcool® and Enviromist® Fog Systems and are primarily used for environmental cooling and vegetable hothouse humidification. The system used for the cargo compartment testing was co-designed by the FAA and EEC and consisted of a high-pressure pump, four zone control valves, and the basic piping and nozzles. The water mist system, designed to minimize the amount of waste water by applying the mist to the areas of the fire, was divided into four zones that could be individually activated (see figure 5). Each zone contained 19 nozzles and covered an area of approximately 4 by 10 feet. The nozzles were oriented to spray mist both horizontally and vertically (down) to maximize mixing and coverage. The mist was automatically controlled by two thermocouples mounted in the ceiling of each zone. The control of the spray activation could be adjusted prior to each test. During the test, when either of the zone thermocouples exceeded the preset value, a signal was sent to open the zone control valve, discharging the mist in that zone. The water mist pressure was adjustable from 800 to 1200 psi, as supplied by an electrically driven pump.

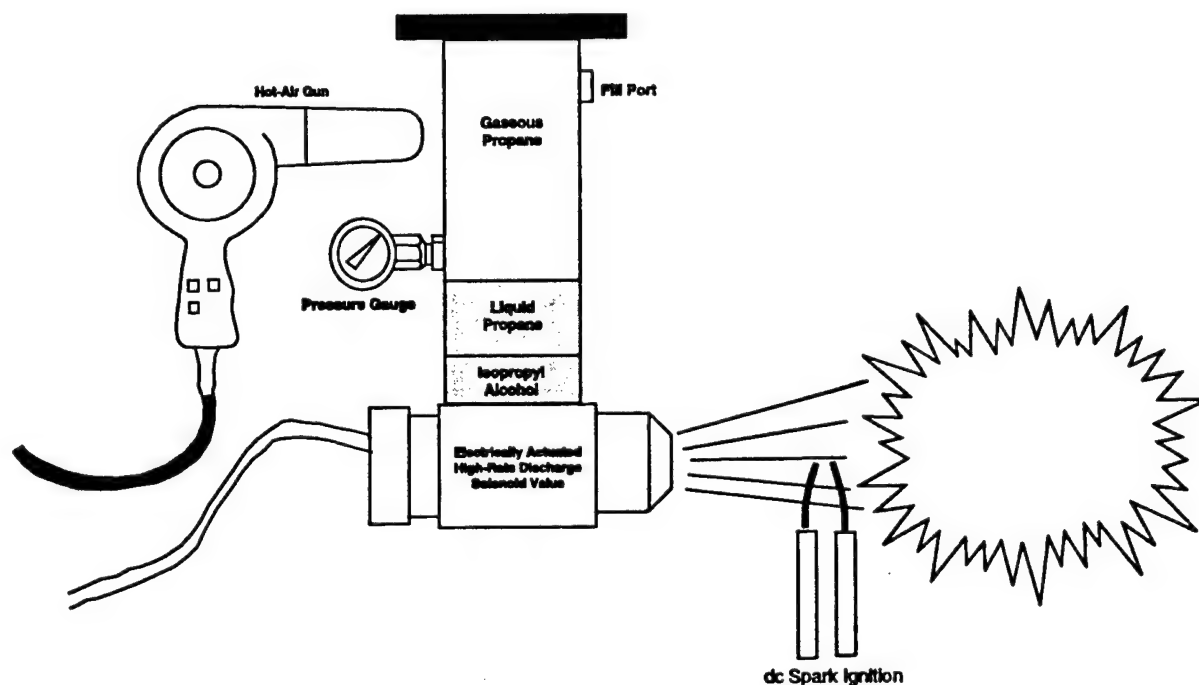
FIGURE 6. EXPLODING AEROSOL CAN SIMULATOR

The initial simulator design was a steel pipe pressure vessel mated to a high-rate discharge (HRD) electrically actuated solenoid valve (see figure 6). The vessel contained ports and valves to transfer the base product (initially isopropyl alcohol) and hydrocarbon propellant (typically propane). The contents are heated by blowing a hot-air gun against the surface of the steel vessel, effectively raising the pressure of the contents. When the pressure was sufficient to burst a standard strength can, approximately 210 psig, the contents were released over a set of direct current (dc) spark igniters. A high-voltage transformer produced the electric spark to bridge the 1.2-cm gap between the pair of electrodes.

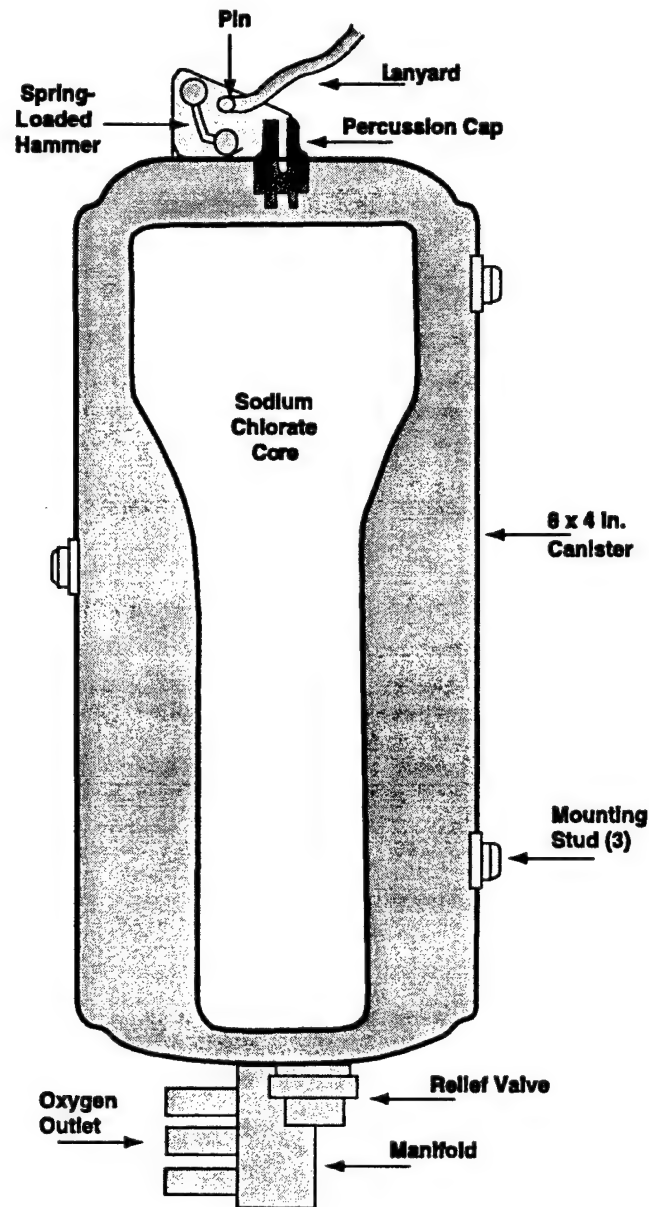
FIGURE 7. CHEMICAL OXYGEN GENERATOR

Most commercial transport aircraft use oxygen canisters to supplement or replace cabin air for passenger breathing in the event of a cabin depressurization. Figure 7 shows the design of a common oxygen canister. The main components are the chemical core composed of sodium chlorate and iron particles, a stainless steel housing, a means of initiating the chemical reaction (such as a spring-loaded hammer striking a percussion cap), and outlets for the gaseous oxygen generated. Because the oxygen-producing reaction is exothermic, the steel housing is insulated from the chemical core to maintain the temperature of the housing below 500°F. As discussed earlier, the activation of improperly packaged and shipped oxygen canisters in the forward cargo compartment was the probable cause of the fatal ValuJet in-flight fire. [5]

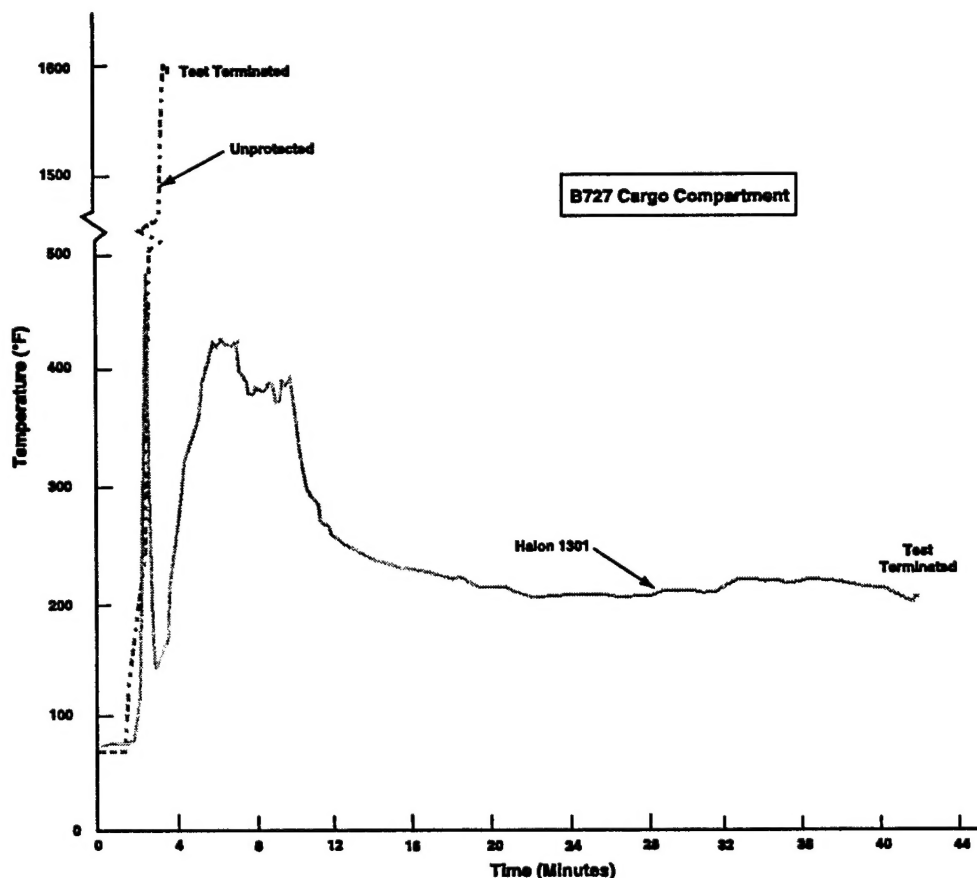
FIGURE 8. COMPARISON OF CEILING TEMPERATURES DURING A CARGO FIRE INVOLVING 12 OXYGEN CANISTERS WITH HALON 1301 SUPPRESSION AND UNPROTECTED

The second test was similar to the first with the following exceptions. Only 12 generators were used; all were stored in one cardboard box. Only a single layer of boxes filled with shredded paper was used. In this test the fire was detected much faster than in the first test (see figure 8). Temperatures at the ceiling never exceeded 500°F. As in the first test, upon discharge of Halon 1301 the visible flaming was immediately extinguished. However, in this test the ceiling temperature was maintained at about 400°F for approximately 10 minutes and decreased to approximately 200°F for the next 30 minutes. After the fire was extinguished, it was discovered that only 2 of the 12 generators had activated.

The third test was a repeat of test two without using any suppression agent. Temperatures at the ceiling rapidly reached the point where the liner would be breached and the test was immediately terminated (see figure 8).

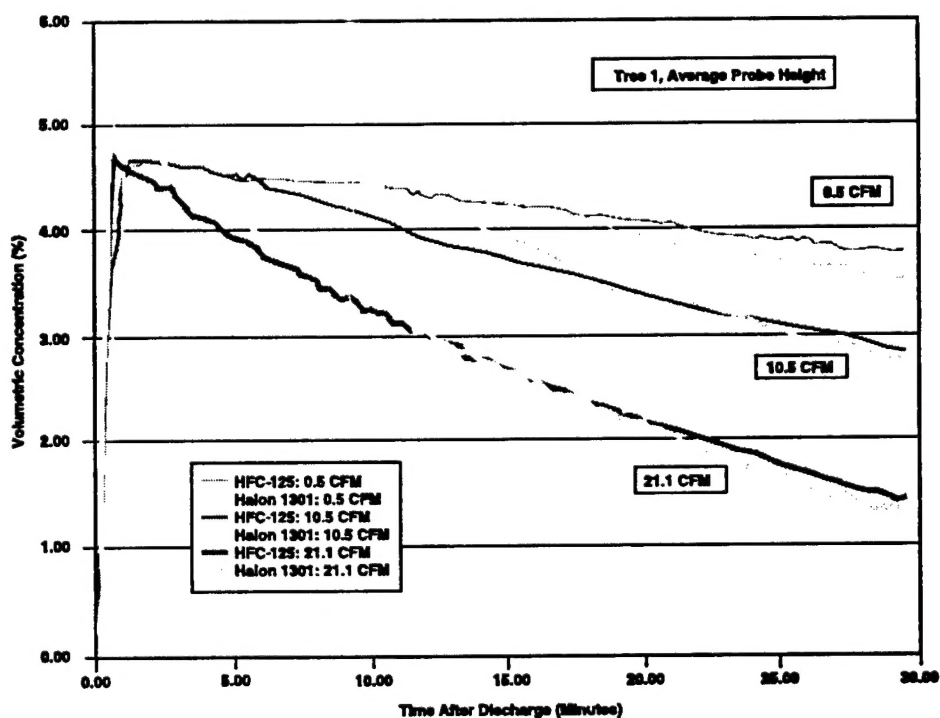
FIGURE 9. AGENT CONCENTRATION HISTORY AT DIFFERENT LEAK RATES

A comparison of the HFC-125 and Halon 1301 concentration histories at the three leakage rates for the sampling tree nearest the leak duct is shown in figure 9. The data represents the average concentration measured at the six sampling heights and from replicate tests at each leakage rate. The higher peak concentrations of Halon 1301 were expected due to the difference in charged weight; 5.8 pounds and 4.45 pounds for Halon 1301 and HFC-125, respectively. Also, the Halon 1301 decays faster than HFC-125 due to its higher vapor density; however, the difference in decay rate lessens as the leakage rate increases. It appears that HFC-125 can be used as a simulant for Halon 1301 provided that suitable conversion equations are used to correlate the concentrations of Halon 1301 and HFC-125.
